BASTIÓN DE SAN DIEGO

INTRAMUROS ADMINISTRATION
MINISTRY OF HUMAN SETTLEMENTS

The conservation of Bastión de San Diego began on March 17, 1979. This initial effort to clear the structure of vegetation and waste led to the discovery of interesting architectural features, many of them previously unrecorded and photographed.

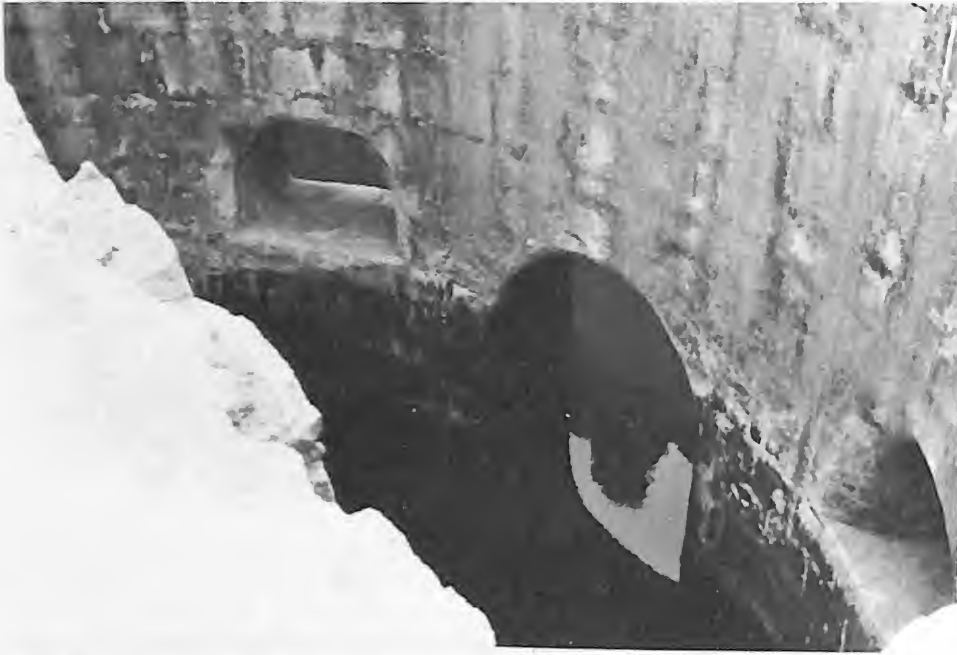
Figure 54. The interior wall of the first circle with a diameter of 8 meters. Picture shows the south section with the archway and two of its three windowlike apertures. A supposition has been advanced that a water gate reaching up to the ledge of the aperture seals the archway.

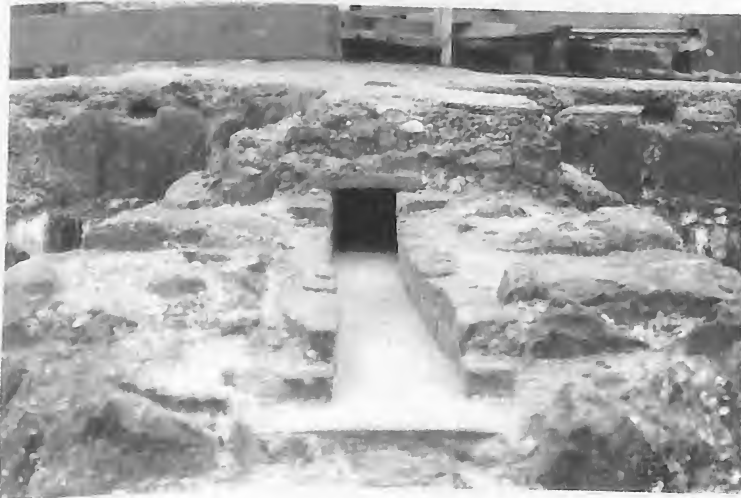
Figure 56. This water duct is built into the dividing wall. Water from this duct travels to the manhole by "spoke D."

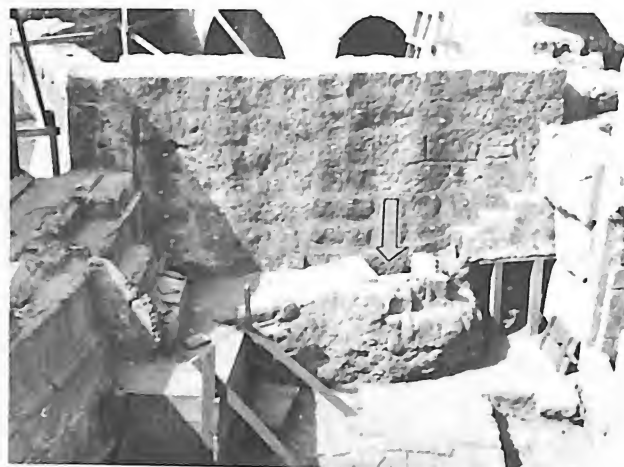
There are three makeshift staircases near "spoke D." All three are built on packed sand (Figures 58 and 59). Two of the stairs interface; one, consisting of two tiled steps, leads up to the wall of the cistern; the one opposite is located by the drainage hole and is propped by wooden stilts. The soil un-

Figure 58. The two sets of stairs facing each other with the "manhole" between them. On the foreground, extreme right, is the doorway of the spiral staircase. The stone flooring belongs to an older period which is possibly related to the spiral staircase.

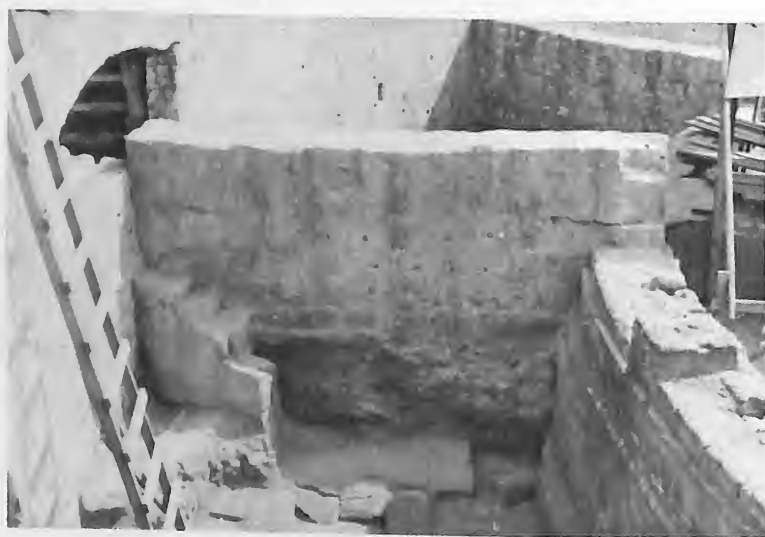
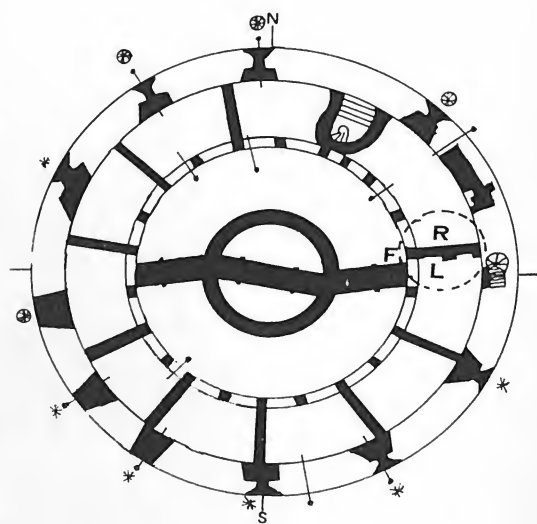
Figure 59. The other side of the stair beyond "spoke D." Accompanying illustration shows the position of the various stones that make up "spoke D."

It is to be noted that the foundation of "spoke D" only consists of well-packed soil fill; only its upper portion is walled by masonry. The steps lead to an opening of the spiral staircase which had been partly covered with adobe (Figure 59). This was a doorway, stepping out to the ground of the third circle, which before the advent of the cistern and other related structures brought one to the patio and the casemates.

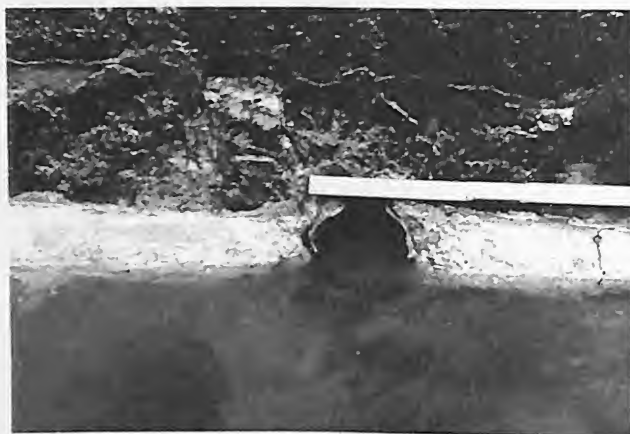
Figure 63. This water pipe with a diameter of seven centimeters is found on the flooring of the second circle on its dividing wall in the west quadrant.

structure (Figures 63-64). Two are on the east side, one positioned at 20 centimeters above the other; another is on the ground floor of the west wall. The brick flooring is 25 centimeters below the water table, hence ground water can be expected to fill up to that level, at least. At high tide, sea water also invades the cistern, a factor which actually contributes to its effectivity as a water reservoir. Since saline water is naturally heavier than fresh water, it settles below, while perched fresh water stays atop the salt water, thus rising high. But this clearly was not enough to fill the huge structures. The apparent source was rainfall.

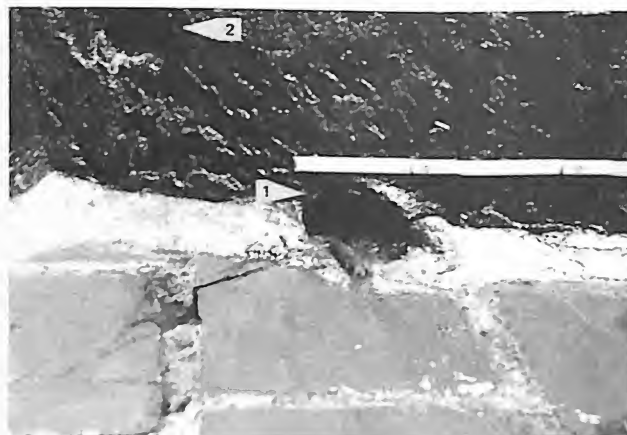
Figure 64. These two tube pipes are located at the bottom of the second circle spaced at a distance of 20 centimeters from the other.

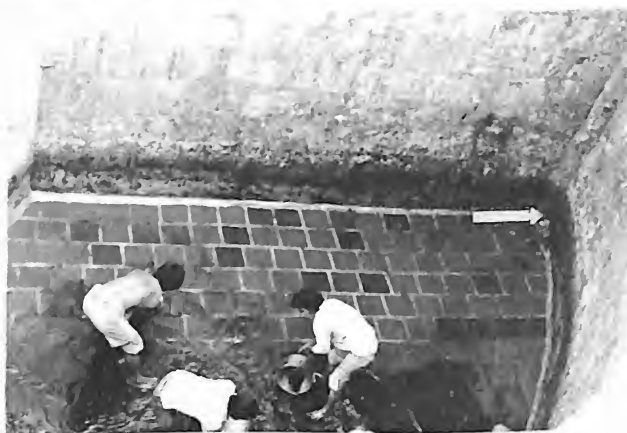
Figure 65. These two holes, also measuring seven centimeters, are located on the eastern corner of the second circular structure. No visible casing can be seen so that the actual purpose of the holes cannot be presumed to be that of water conduits. Perhaps, they were clean-out holes plugged when not used for such a purpose.

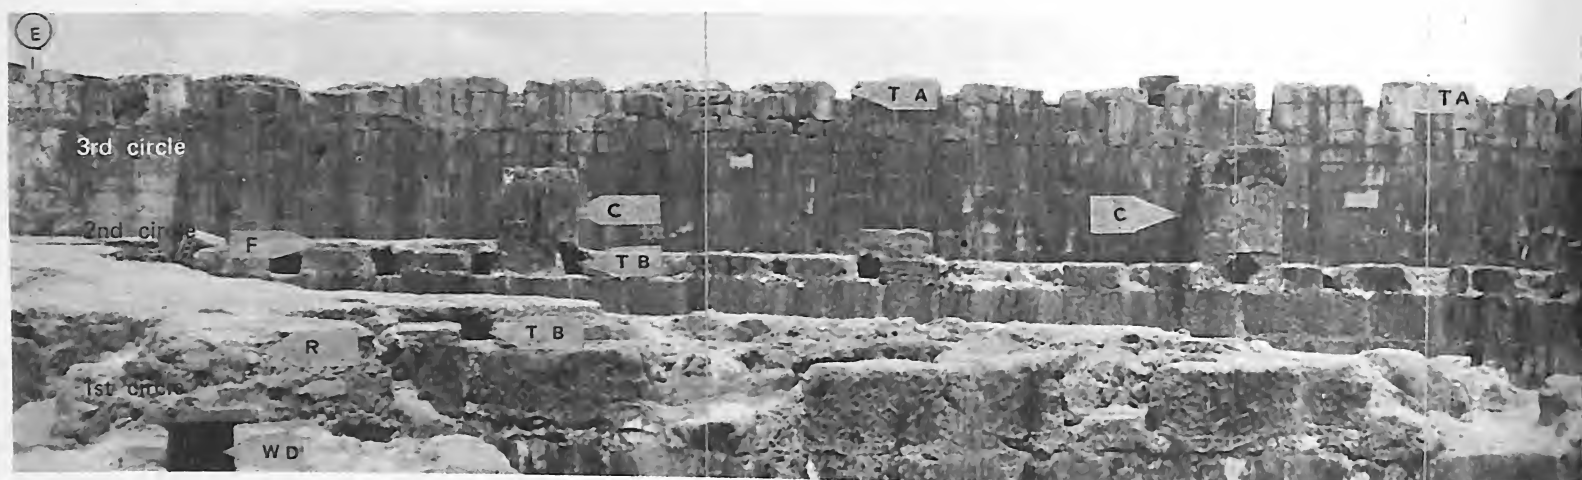
Figure 68. The top section of the outer bulwark and the cistern showing the timberholes, pillars and dividing wall. Roofing structure of the third circle rests on a post implanted on the pillar or column.

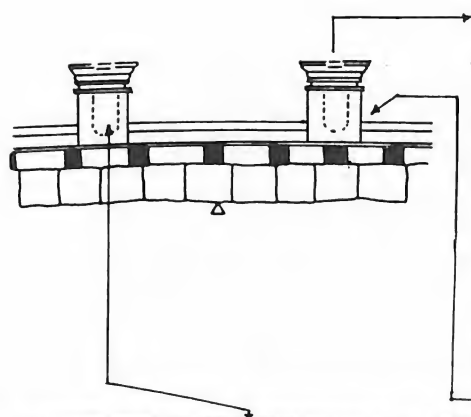
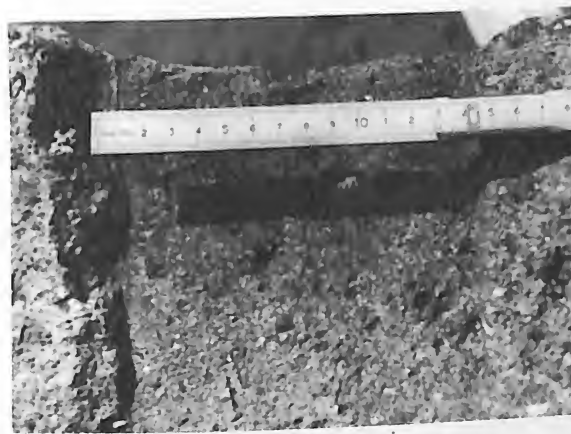
Figure 72. The front side of the top portion of the column slants downward with a depth of 4 centimeters.

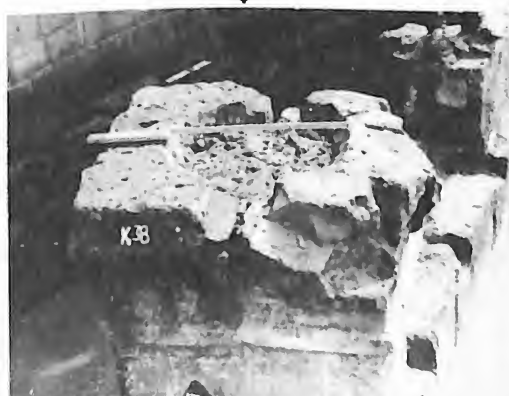
Figure 73. The height of this column is 1.08 meters and the entire body measures 60 centimeters. Top of the column has a circular hole measuring 30 centimeters in diameter extending downward for about 90 centimeters (see drawing).

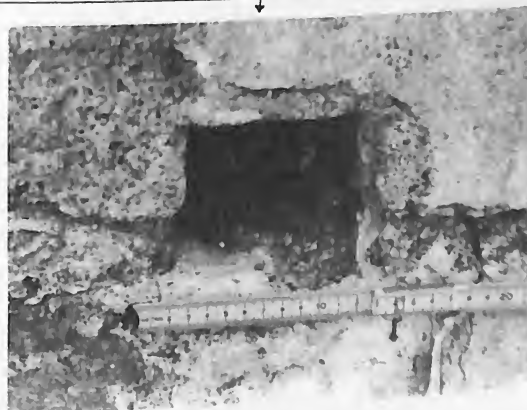
Figure 74. This square hole is one of two located on either side of the column. This feature accompanies all the columns excavated on top of the structure. Each hole measures about 10 centimeters.

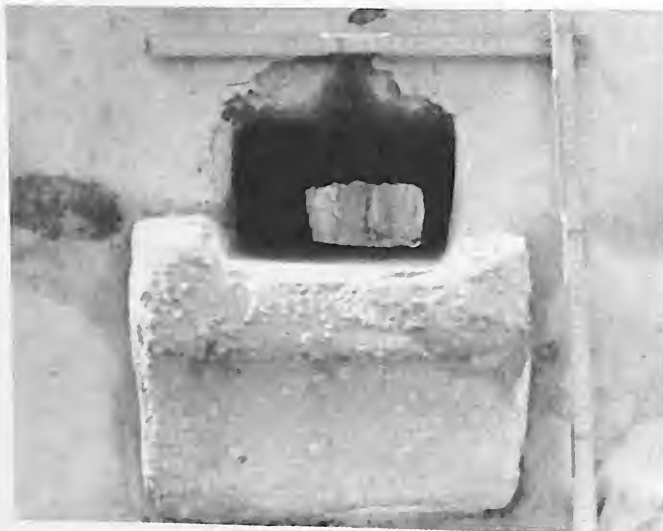
Figure 75. One of the four ducts found on the dividing wall. Only one side of these ducts has spouts; the reason for the omission is not clear, since its obvious function is to keep water at the same level and not necessarily to drain off water to the other side.

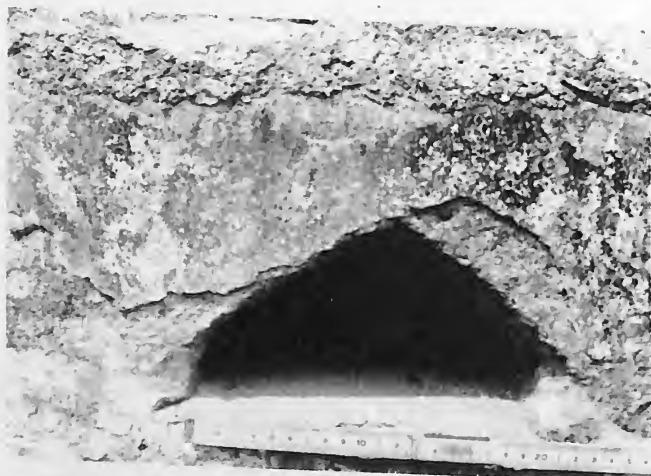
Figure 76. A triangular water duct located at $N 27^{\circ}E$ of the second circle. Water that passes through this duct travels straight on to a drainage.

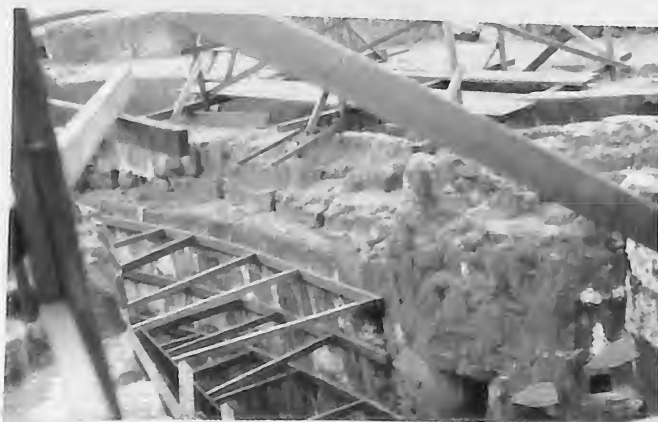
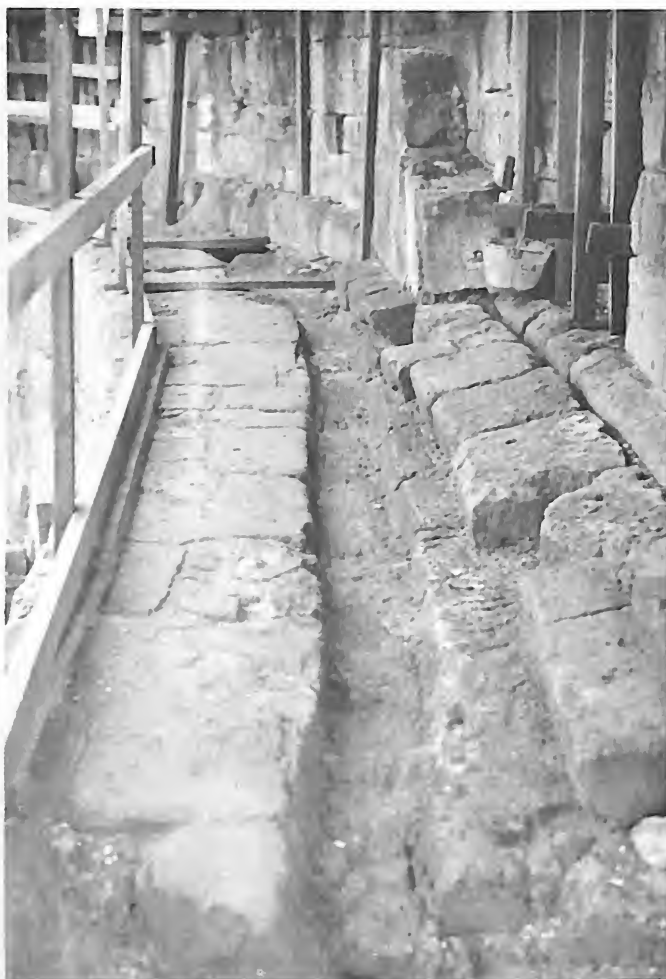
Figure 78. Waterway found on top of the third circle. The canal may have originally been covered with adobe. It may have been built to prevent build-up of water on the top of the structure.

Figure 77. A system of drainage found within the third circle's top wall. Water drains out to the terreplein. The system may have belonged to the old tower.

Surrounding the third circular structure on the terreplein is a canal-like groove. The portion on the northeast section is still fairly complete, and here the stone arrangement on the outer edge is tipped toward the groove. Indications also show that the canal was previously covered with adobe stones (Figure 78). Simple tests were conducted to determine the passage of water into the structure. Large quantities of water were poured into the canal which invariably traveled to the duct on the dividing wall. Gurgling sounds were heard around the "manhole." It was then supposed that water passing through the duct on the dividing wall inevitably ended in the "manhole." But it was not evident how the water reached there. That water was kept clean by a cover of adobe stones seems to represent an intention to conserve this water as well. Of course, one obvious reason for lining the top of the canal was to make it a more convenient walkway.

On the interior wall of the third circle on the west quadrant, there is a series of grooves that leads to a duct, which we assume to be a drainage outlet (Figure 77). We could only listen to the sound of water trickling down the structure. How its system operates is another matter that for now must remain a mystery. For to learn of its function and its value, one has to dismantle it. This would require such careful documentation and study and the supervision of an archaeologist in removing and restoring the stones. Only in this manner could one guarantee its faithful restoration, and unless this was ensured, it would be best to leave it well alone. It had survived several centuries of oblivion and neglect; it would be a pity to see it destroyed now by good intentions.

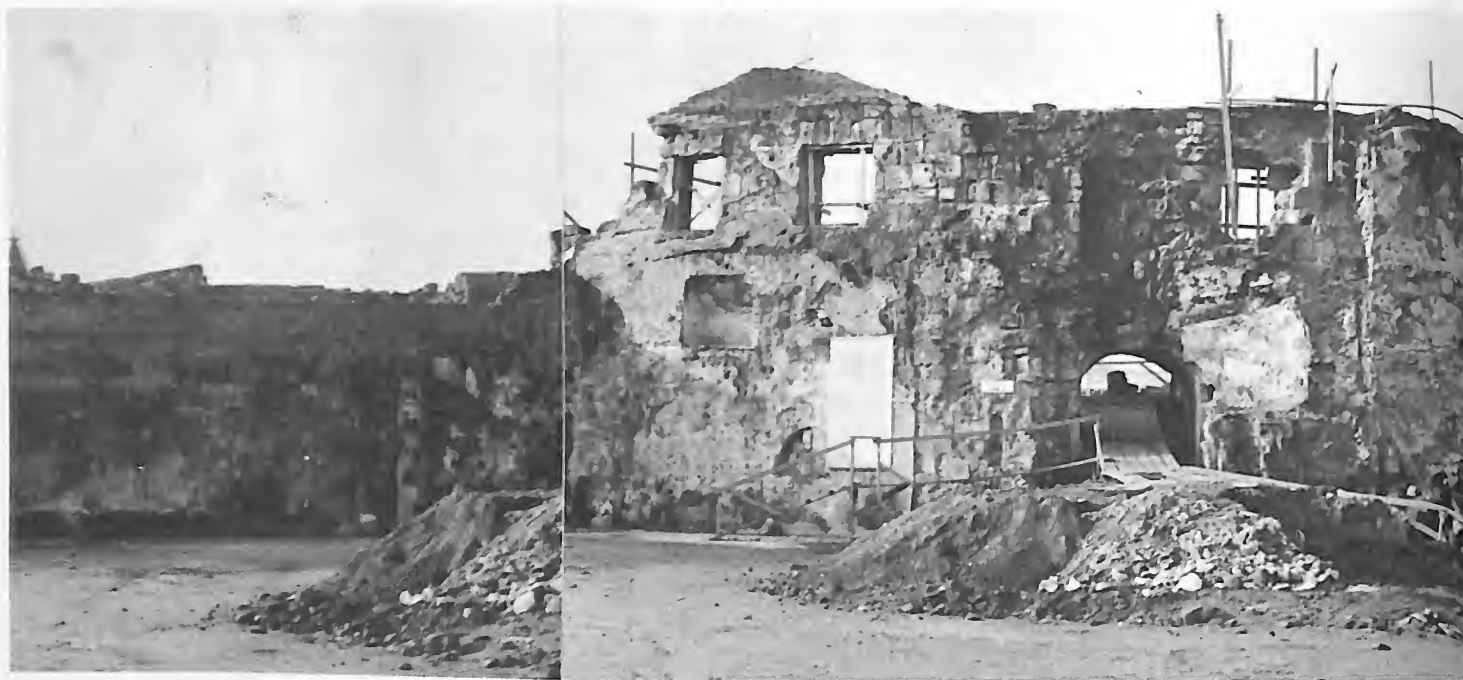
Photograph shows the condition of the west flank. The central portion of the drawing shows how mojonos—landmarks—were used to shore up eroding portion of the wall.

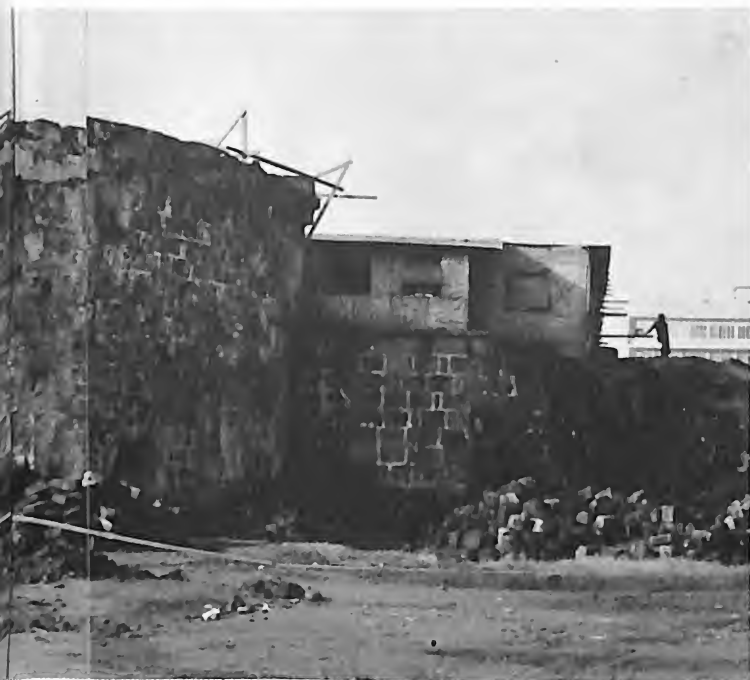
The façade of the Bastión de San Diego facing the Pamantasan ng Lungsod ng Maynila. The two casemates on the right side of the picture probably belong to the period of Vera and Sedeño or to the period of renovation instituted by Manrique de Lara. The eroded portion indicates the location of the ramp documented in the plans of Dionisio O'Kelly and Thomas Sanz, 1770 and 1779. The extreme left marks the location of the ramp, stair and wall documented in Sanz's plan of 1779. Though these projects are classified under obras executadas, there are no archaeological evidences of these structures.

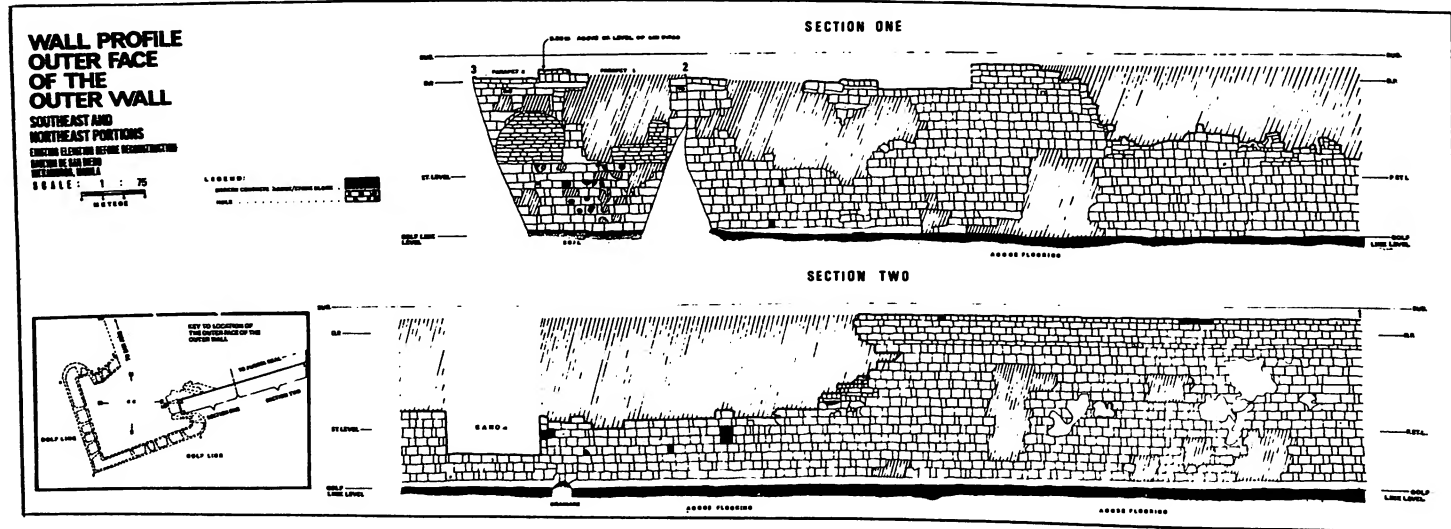
The status of the wall on the northeast portion and, below, the status and elevation of the wall on the southeast curtain wall.

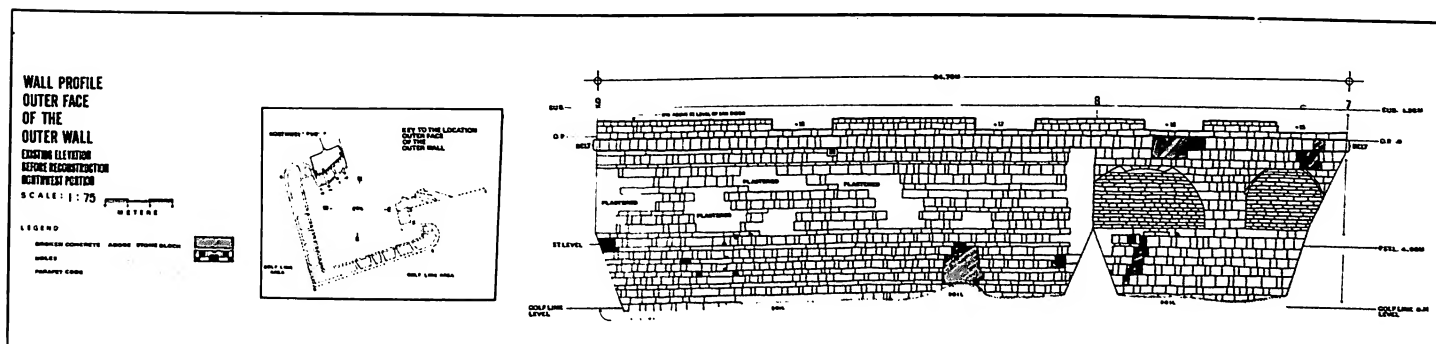
Existing elevation and status of the wall before reconstruction of the northwest portion.
